SEATTLE PUBLIC LIBRARY UNIVERSITY BRANCH RENOVATION

BUILDING HISTORY, EXISTING CONDITIONS, & PRINCIPLES

BUILDING SUMMARY

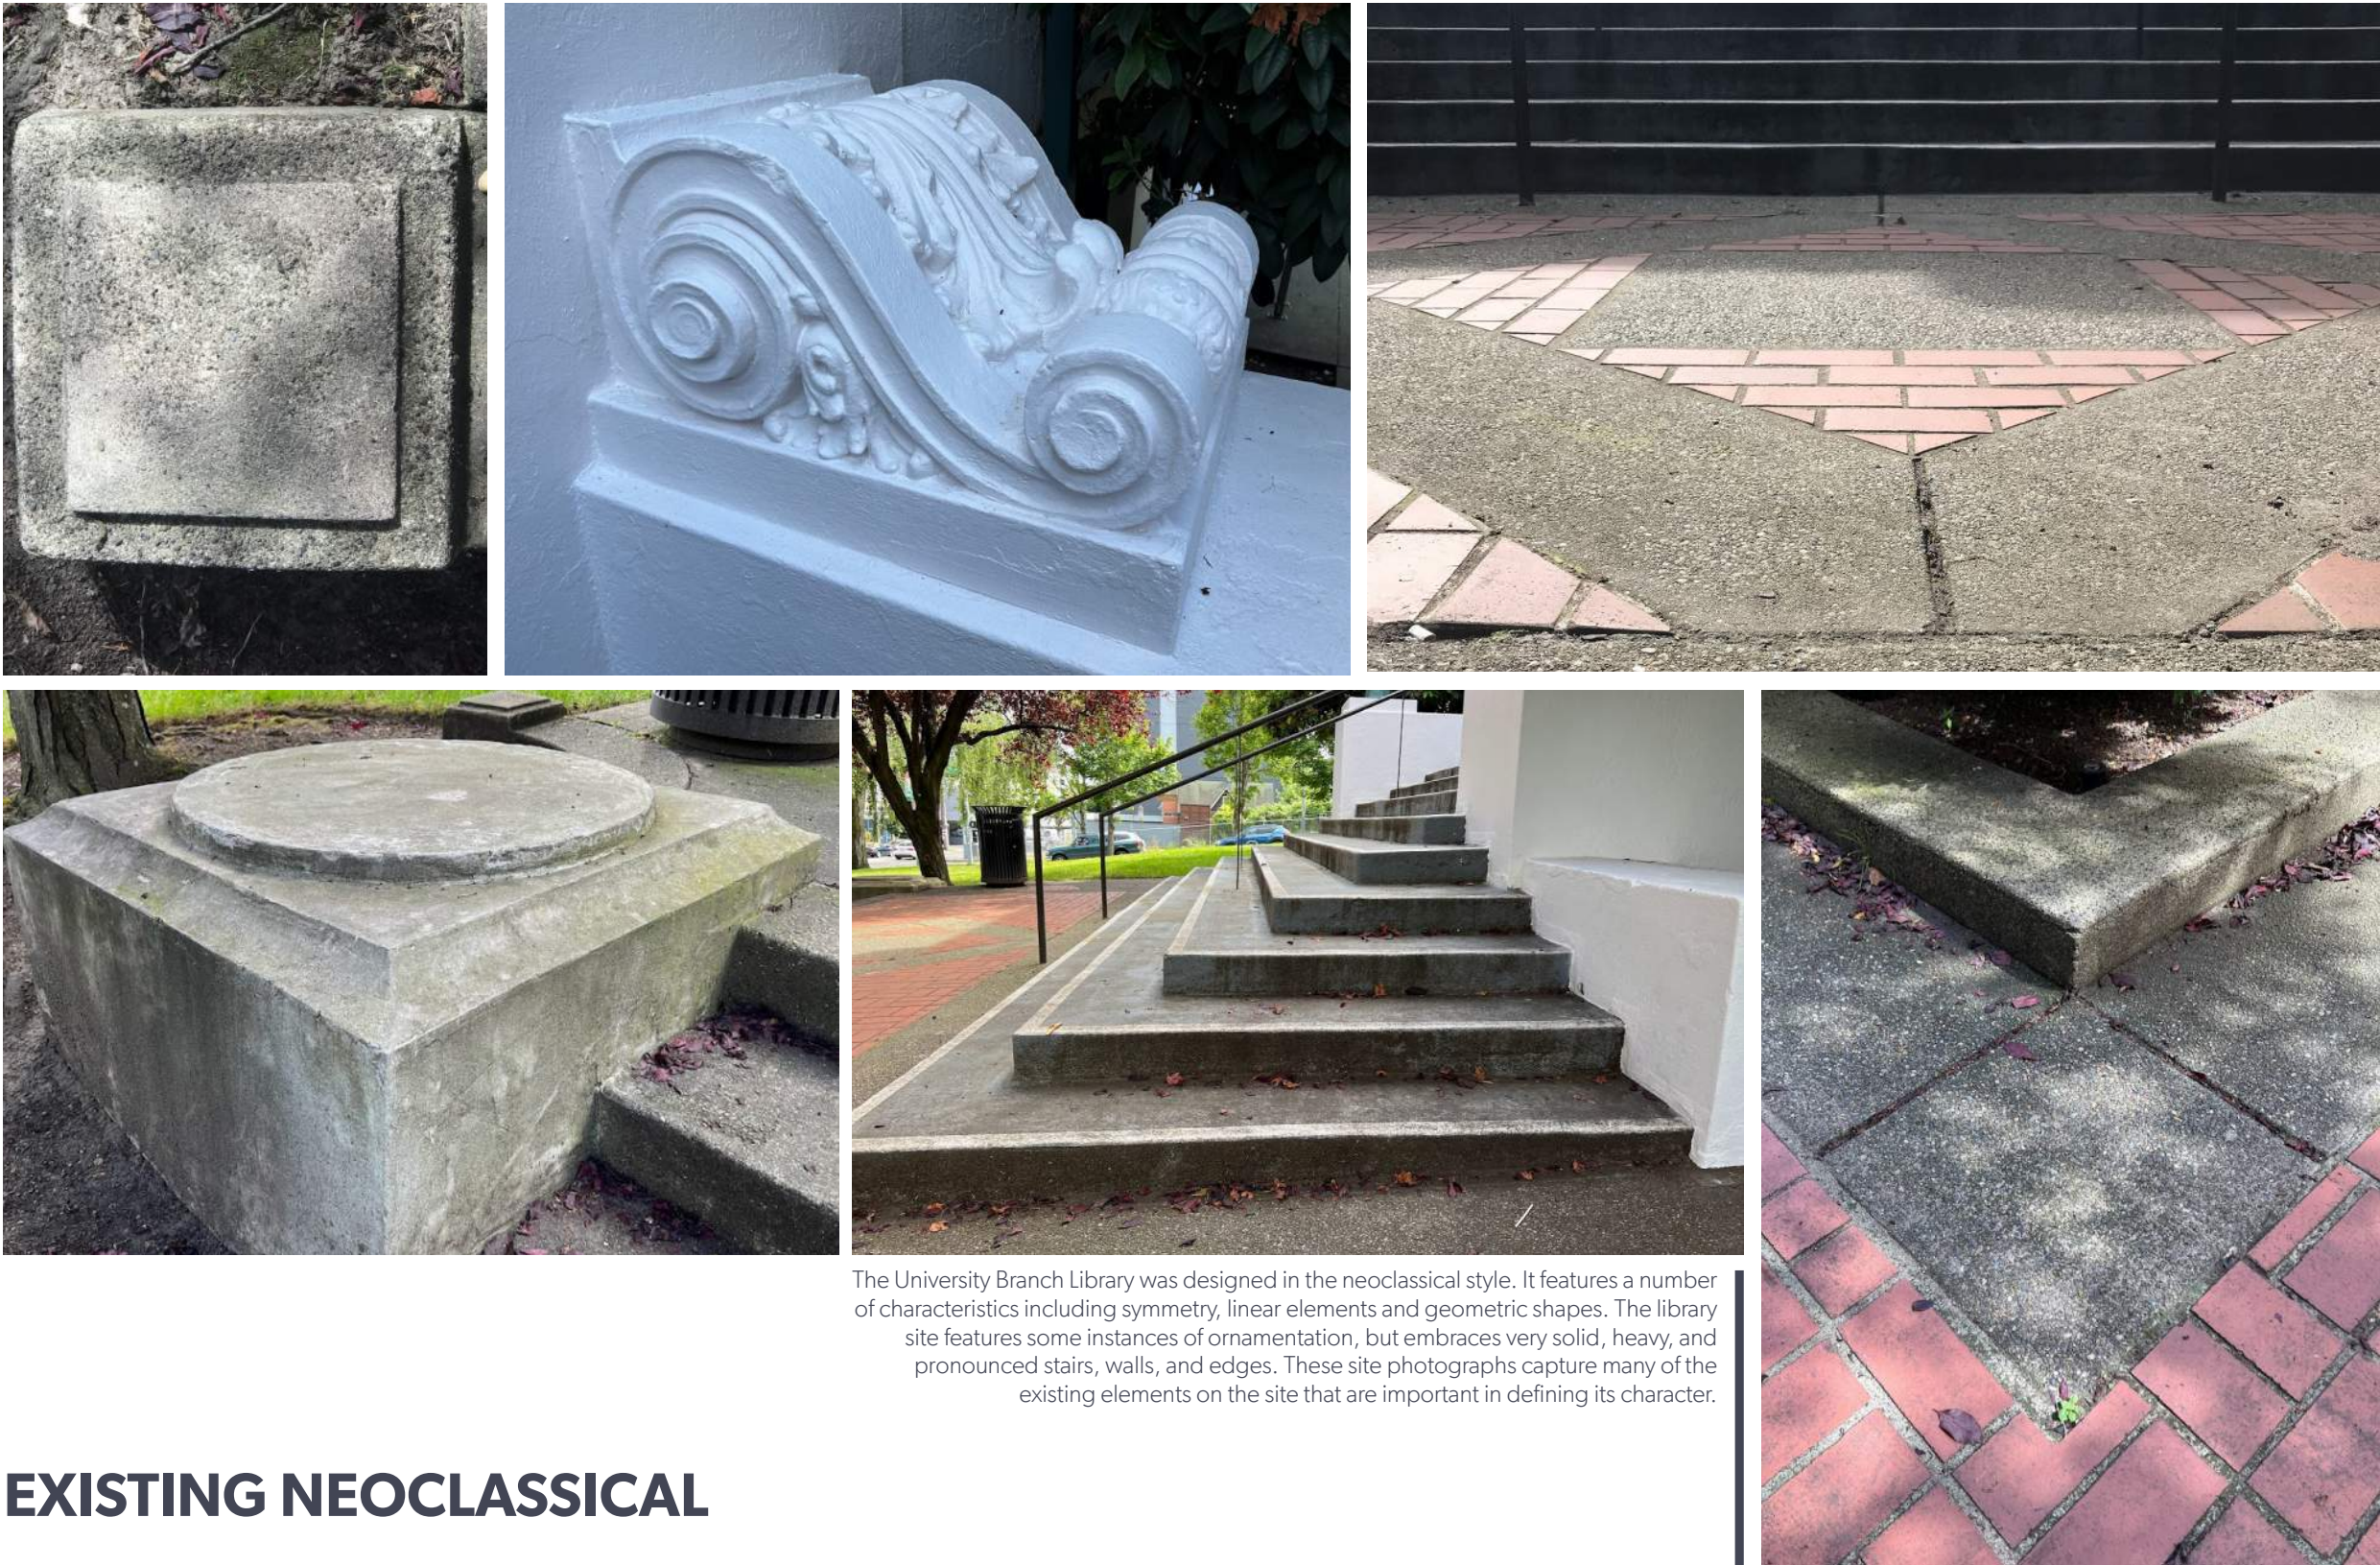
EXISTING NEOCLASSICAL

The University Branch Library was designed in the neoclassical style. It features a number of characteristics including symmetry, linear elements and geometric shapes. The library site features some instances of ornamentation, but embraces very solid, heavy, and pronounced stairs, walls, and edges. These site photographs capture many of the existing elements on the site that are important in defining its character.

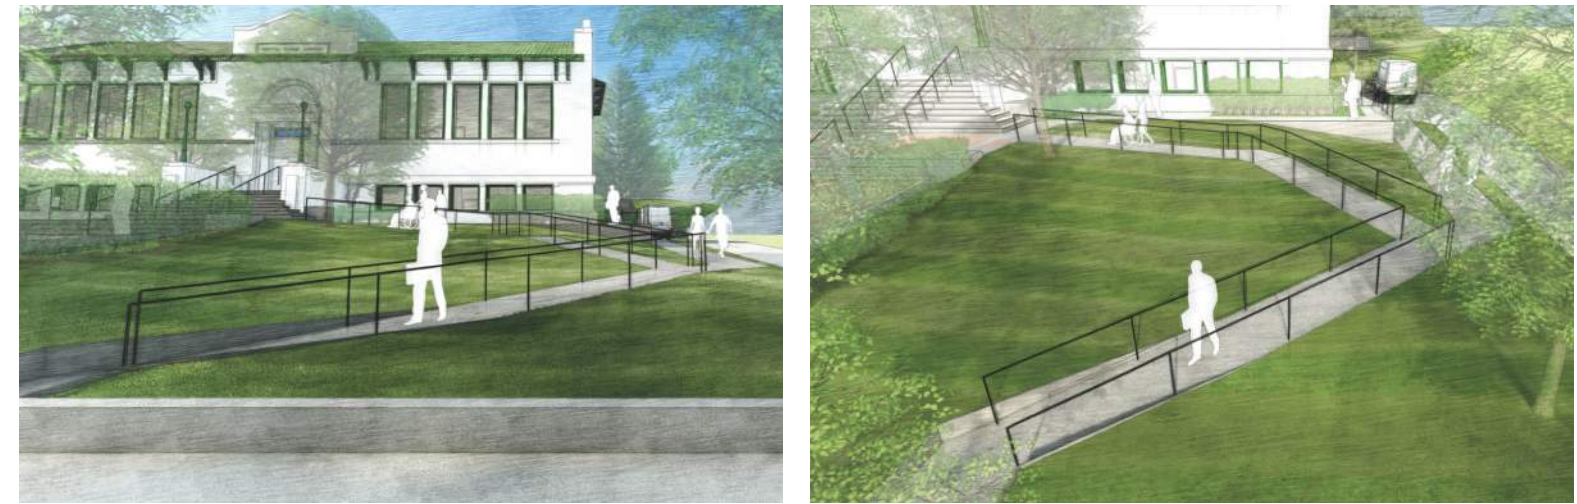
NE SITE AREA - ROOSEVELT WAY NE ACCESS - DESIGN EVOLUTION

CURRENT SCHEME ADVANTAGES:

- Pathway trajectory minimizes impact on existing trees.
- Ramp section with rails location minimizes impact on east elevation to maintain symmetry.
- Sloped walkways make up most of the grade change - gradual and easier to navigate.
- Stair relocation makes site navigation more intuitive.
- ADA access from street to both lower level entry and to south pathway ADA improvements, connecting entire site.

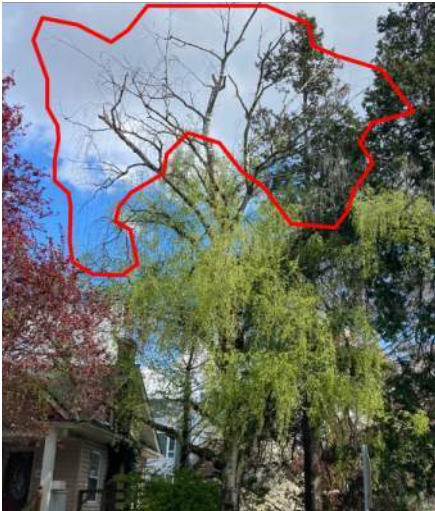
Tree 276 (northwest), significant dieback

Tree #267 (white birch) at northwest corner of the site is also **proposed to be removed**; the arborist report indicates it to be in poor condition and **unlikely to recover from birch borer disease.**

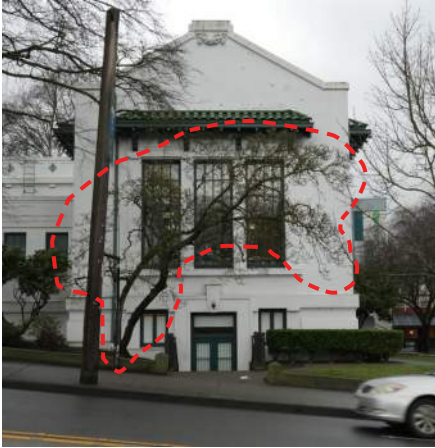
Tree 267 (south)

South & West Tree removal:
Tree 276 (magnolia) at the south walkway is proposed to be removed as indicated in the arborist report; while it was indicated as in good health condition, **its critical root zone conflicts with the proposed concrete accessible path. It is proposed to be replaced with a Karpick Red Maple.**

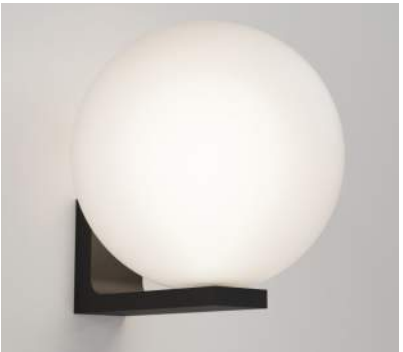
Mnfr: DeltaLight
Model: Oono W L
Size: 8"Dia & 12"Dia
Finish: Black, white diffuser
Notes: Replaces existing sconces
N/S lower entry & west elev

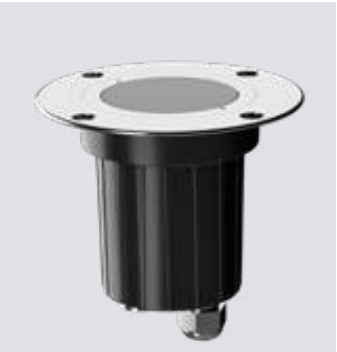
Mnfr: Interlux
Model: Suelo series
Size: 4.7"Dia x 6.1"D
Color: Standard (stainless)
Notes: In-ground uplights

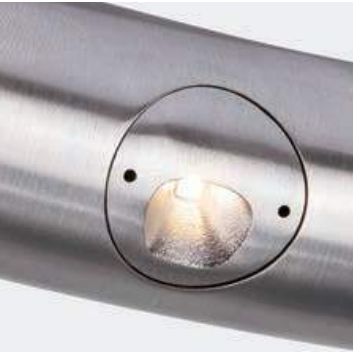
Mnfr: Wagner
Model: Lumenpod 28 Series
Size: 1"x1"
Color: Standard, painted
Notes: Integral handrail

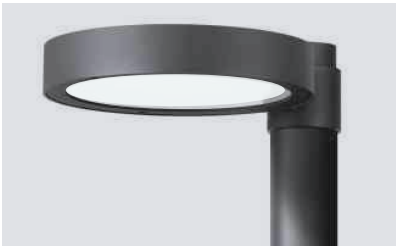
Mnfr: Bega
Model: 99407 Series
Size: 18" x 24" x 2.25" (14' pole)
Finish: Black
Notes: West parking lot

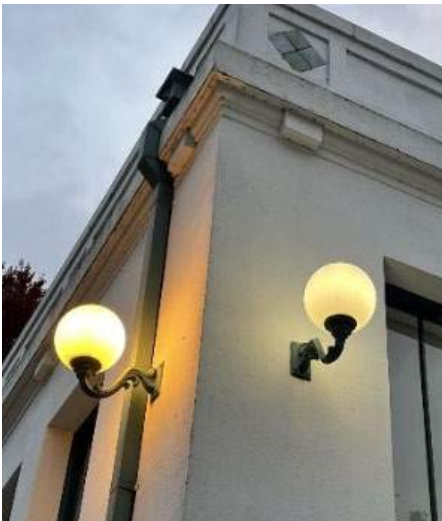
Existing sconces, circa 1954
(proposed to be removed)

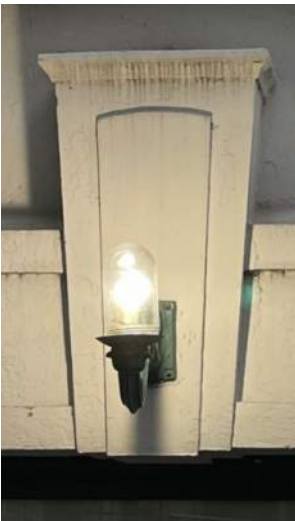
Existing sconce, circa 1989
(proposed to be removed)

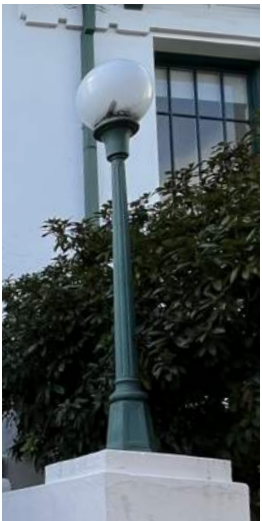
Existing pole
(proposed to be restored)

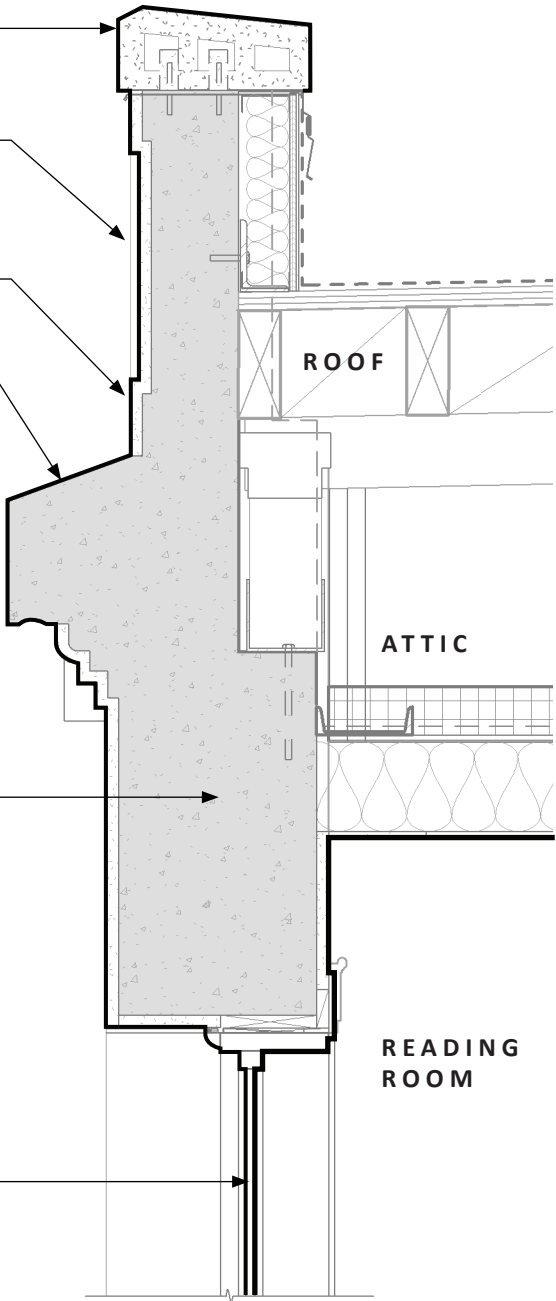
WEST WALL SECTION

REINSTALL
TERRACOTTA
COPING CAP
REINSTALL TILES

CONCRETE
SHEAR WALL,
STUCCO &
PAINT FINISH

REINSTALL EXISTING
WINDOWS

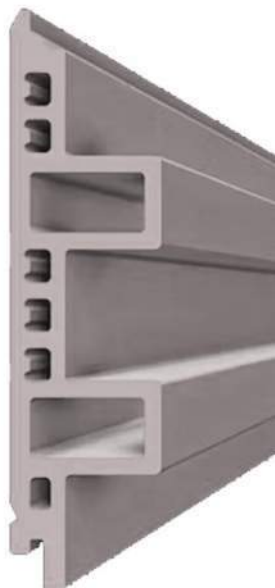
Horizontal

A horizontally oriented profile tests the hypothesis of vertical grain. Horizontal layouts contrast with the vertical grain of the existing building windows and mullions.

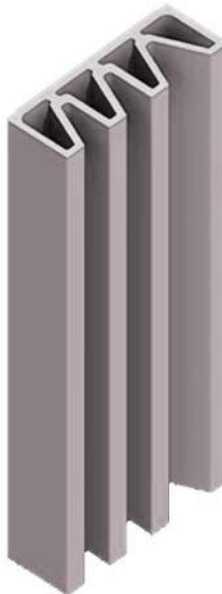
Custom Verticals

A variegated custom profile carries the same benefits of a more regular vertical while introducing variation to the rhythm, reflecting the natural variation of the existing stucco. This is consistent with an approach of complementary yet differentiated cladding building elements.

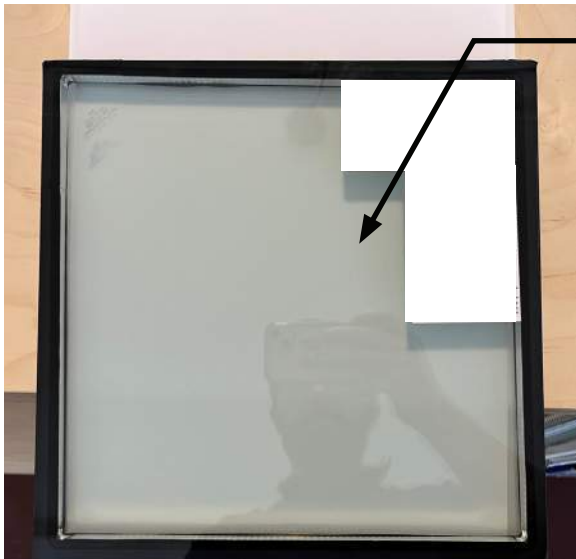
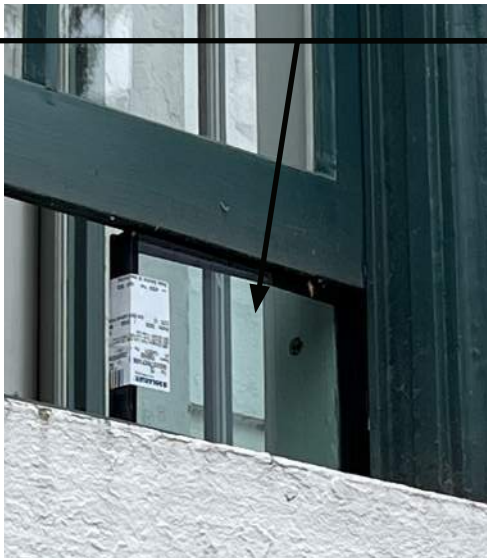
IGU GLAZING (ALL NEW EXTERIOR GLAZING)

BASIS OF DESIGN/SAMPLE: HARTUNG INDUSTRIES IGU, SOLARBAN, LOW-E COATING.

CLEAR LAMINATED GLAZING (ALL NEW INTERIOR GLAZING)

BASIS OF DESIGN/SAMPLE: HARTUNG INDUSTRIES, CLEAR TEMPERED LAMINATED

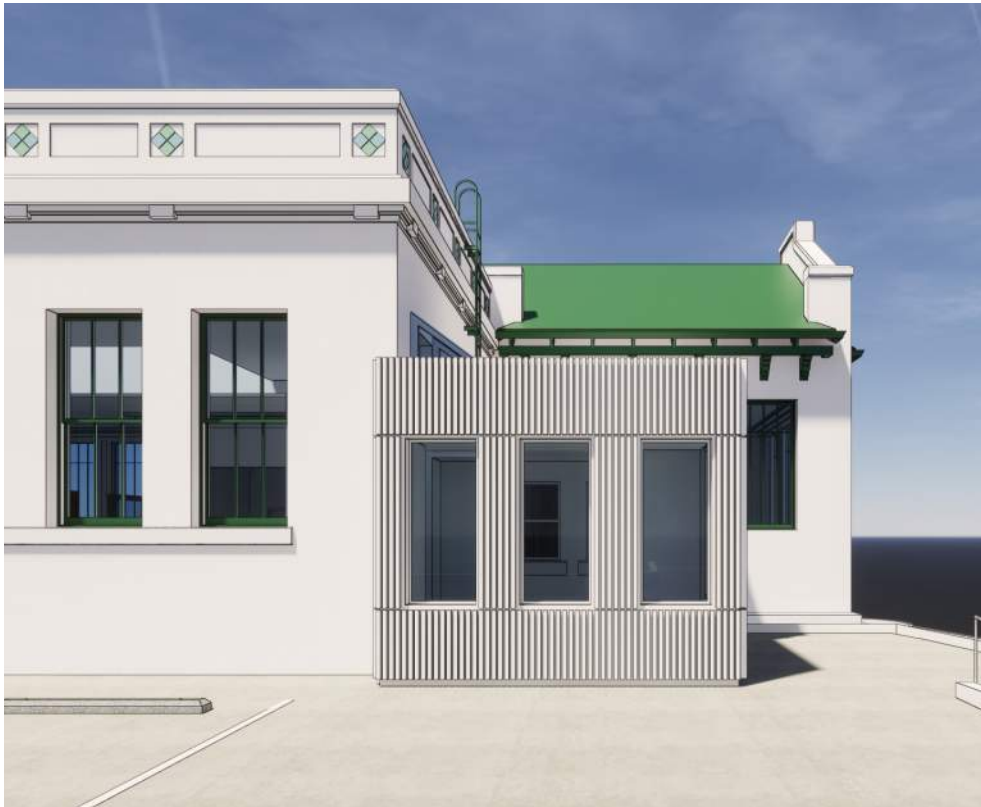
VERTICAL OPENINGS

Purely punched openings—especially vertical—imitate the existing windows. By contrast A carved corner window responds to and differentiates itself from the original building's in a method compatible with monolithic buildings (contemporary examples shown at right).

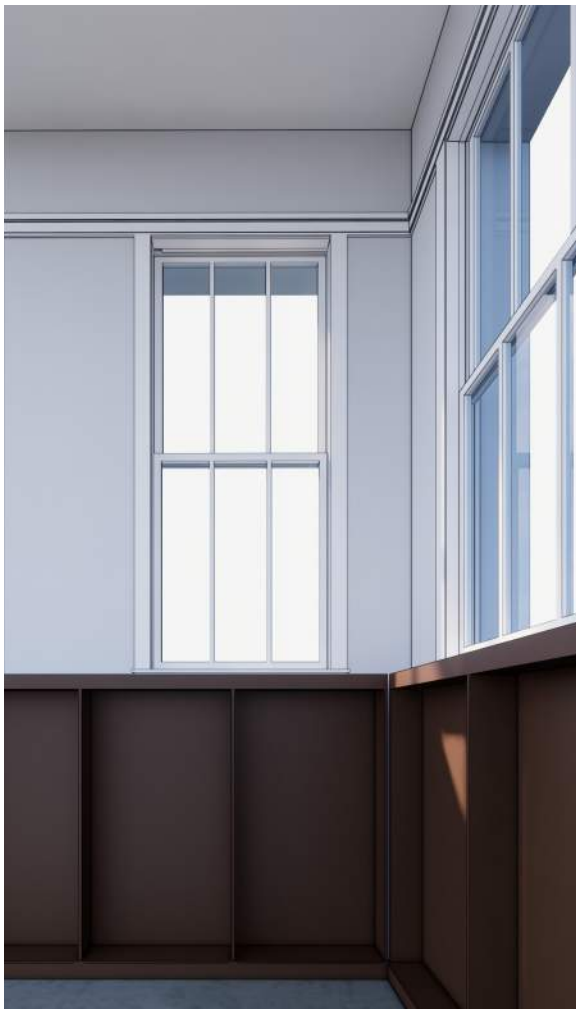
Existing Condition

At the April 6th Landmarks Preservation Board Meeting, the board requested the development of alternate approaches to the SW entry opening treatment to assess the appropriateness of the proposal. SHKS developed a number of schemes with a range of approaches to window grain and retainage of the existing window.

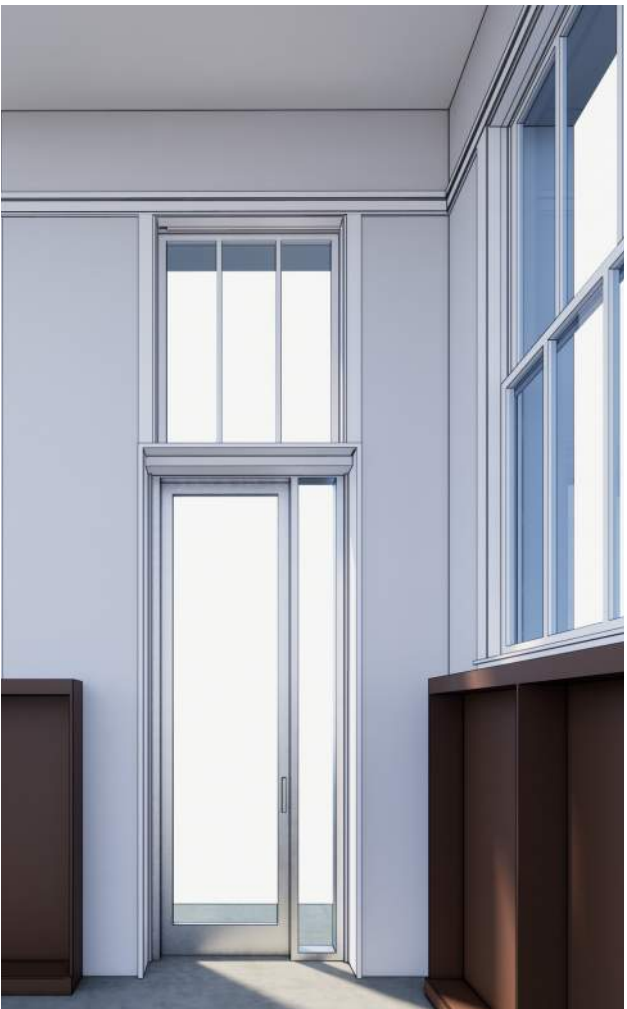
3: Retain Upper Sash

- Retains portion of original window
- Transom or tall door required to bridge gap
- Lintel delineates old & new openings

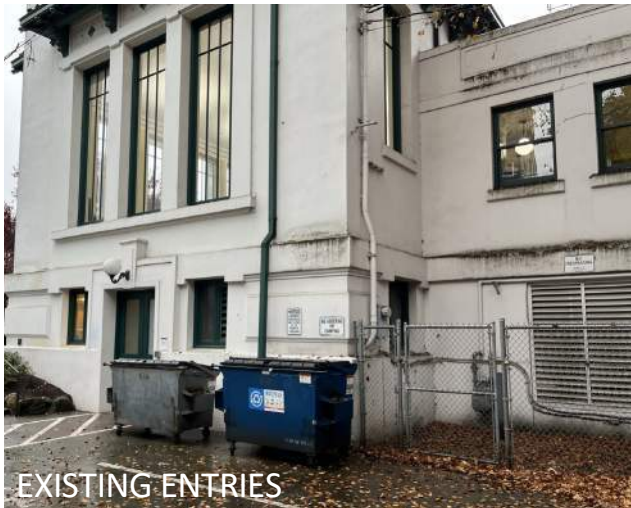
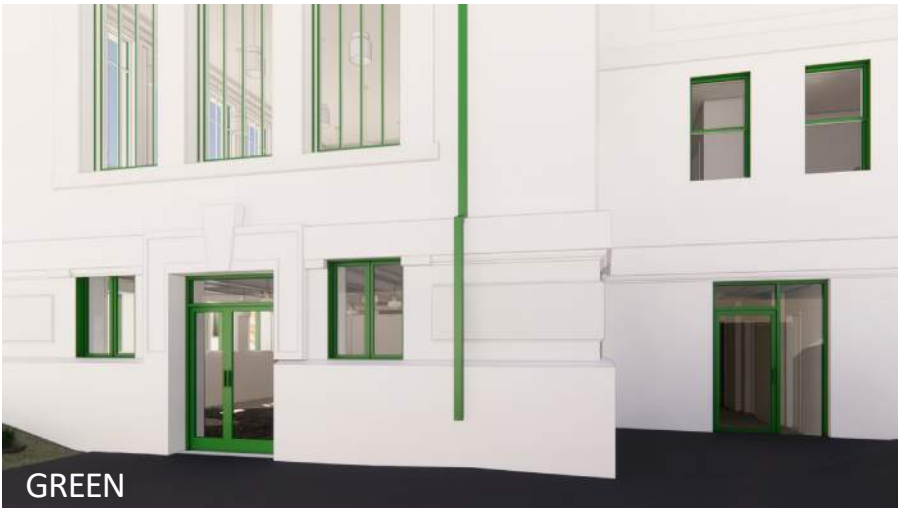
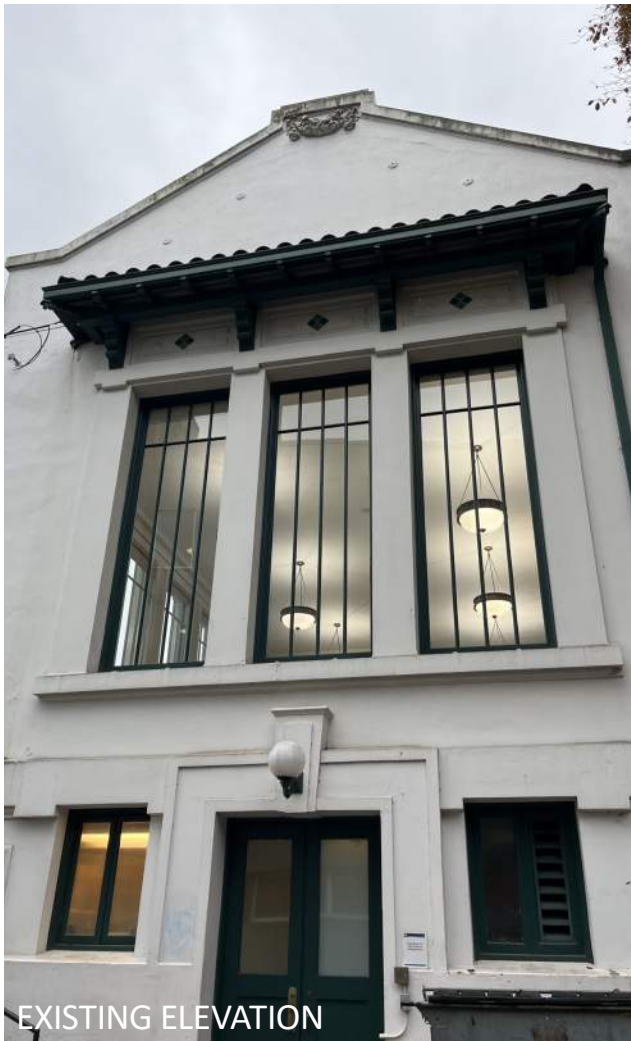
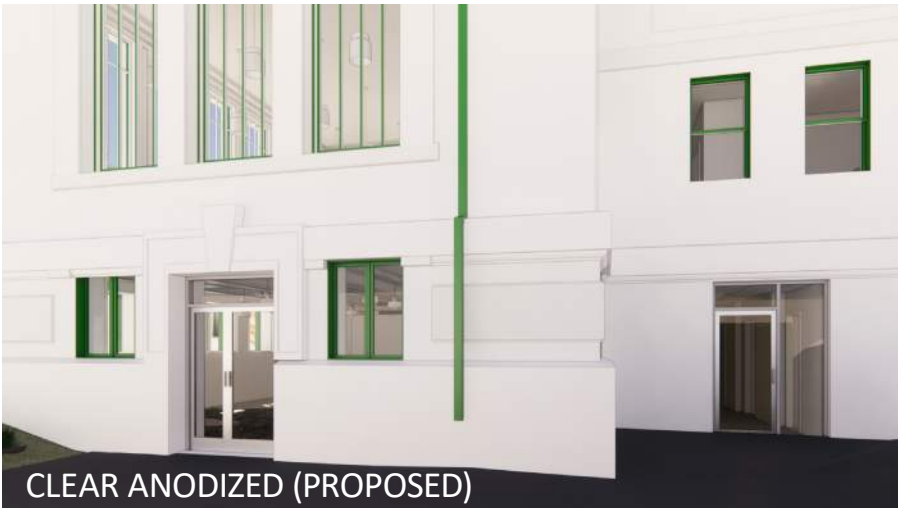
FLOOR PLANS AND OPENINGS - LOWER LEVEL

North Elevation Openings:

Relocation of the lower level meeting room requires modification or replacement of the existing original double door to meet egress requirements (min. (1) 3' wide leaf).

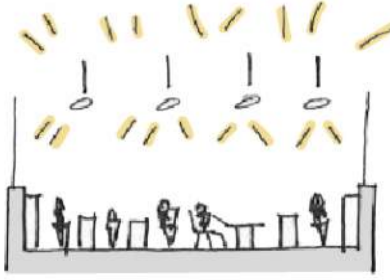
PROPOSED "FIELD OF LIGHT"

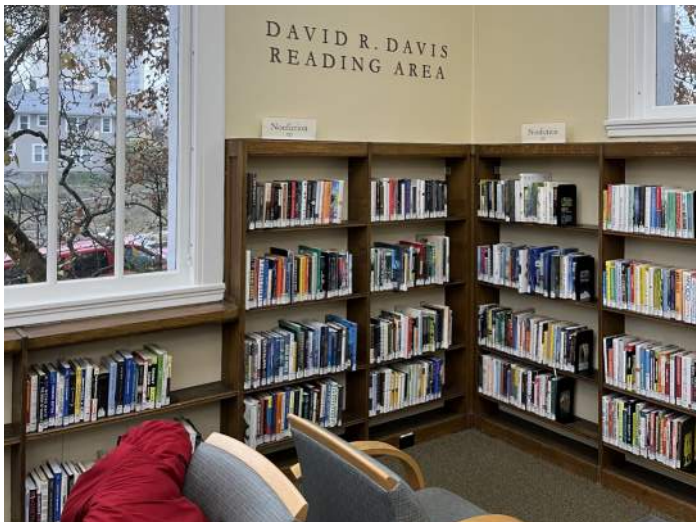
EXISTING SHELVING

Reading room perimeter shelf backing

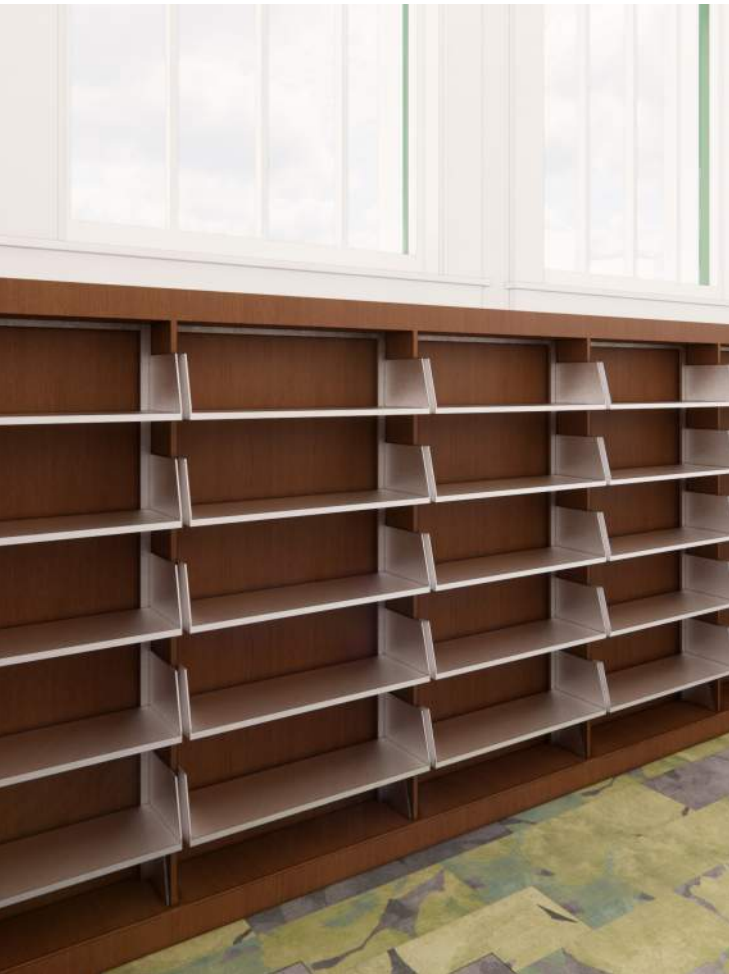
PROPOSED: STAINED PLYWOOD BACKING + WHITE SHELVES

Install white metal shelving on veneer plywood backing, stained to match the existing casework verticals and trim. The stained veneer plywood backing refers to and retains the tactile quality of the original wood shelves, and the white shelving is clearly differentiated from original material.
